NASA/TP-97-206257

The Characteristics of Fatigue Damage in the Fuselage Riveted Lap Splice Joint

Robert S. Piascik
Langley Research Center, Hampton, Virginia

November 1997

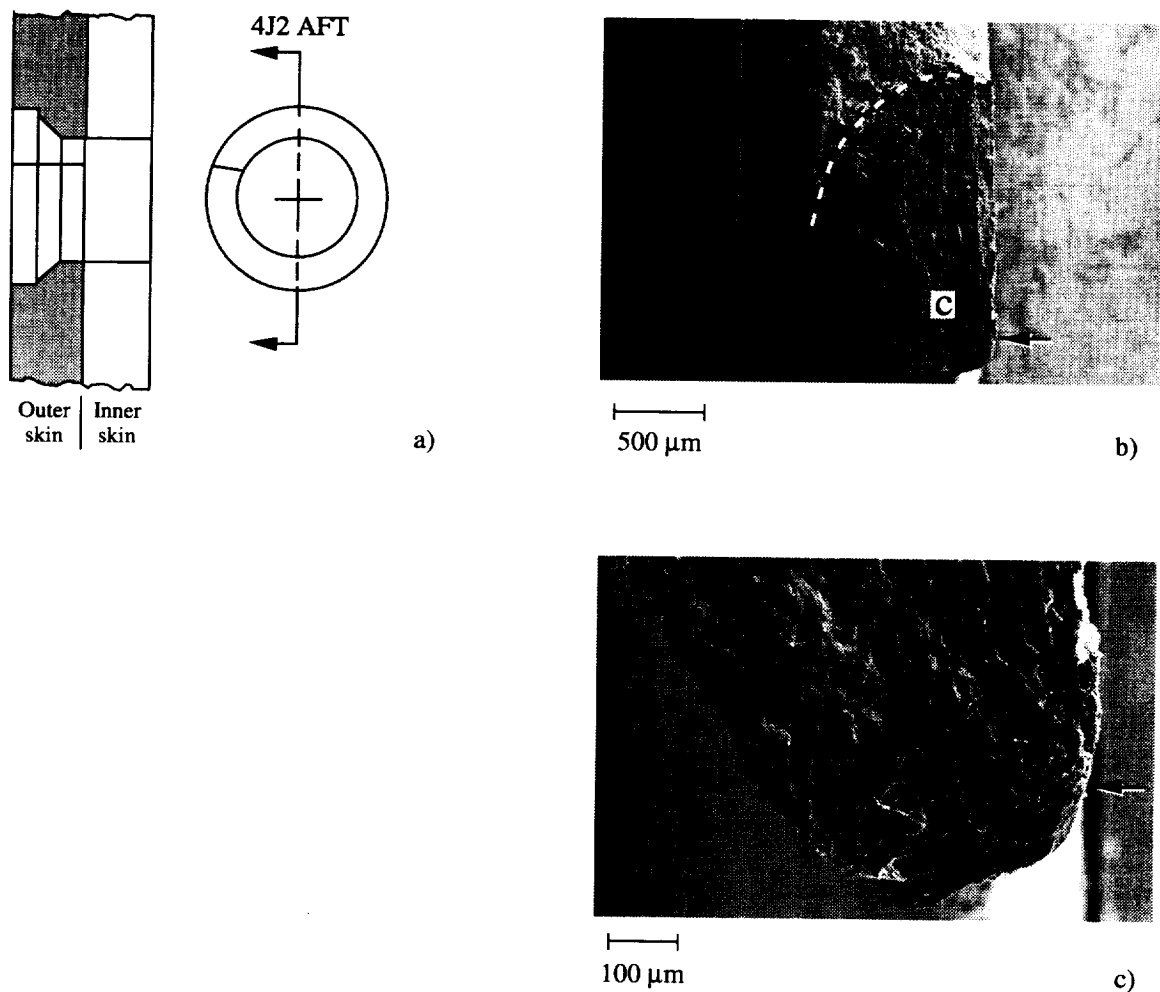
Figure 11.12 a) The schematic shows the rivet hole 4J2 configuration and the location of the outer skin fatigue crack oriented in the aft direction and about the 10 o'clock position. b) The SEM micrograph shows the fatigue crack fracture surface located at the outer skin rivet hole (bottom). The arrow marks the likely crack initiation site and the dashed line marks the fatigue crack front. c) The SEM micrograph shows the fatigue crack front region "c" in Figure 11.12.b. The arrow marks the region of crack initiation.

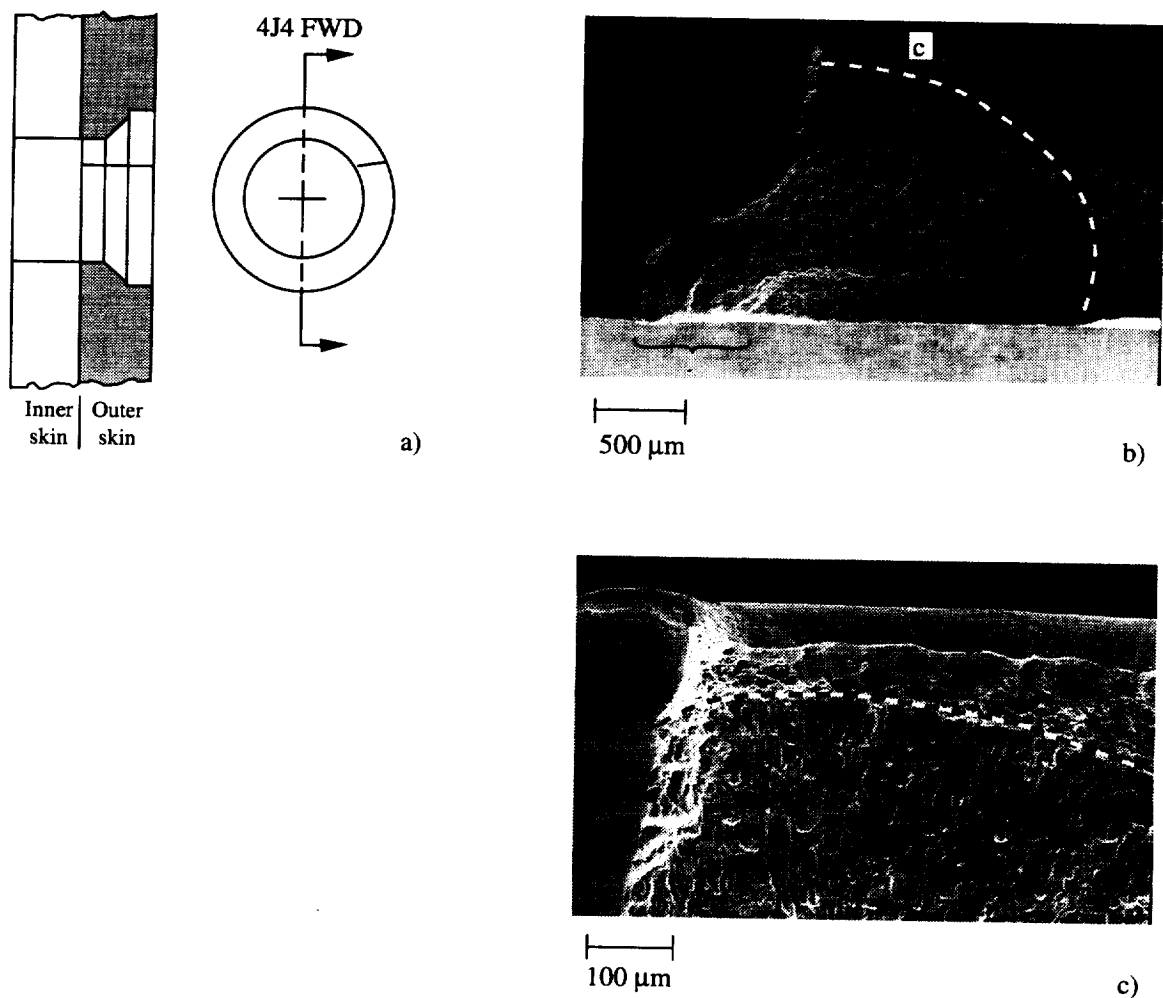
Figure 11.14 a) The schematic shows the rivet hole 4J4 configuration and the location of the outer skin fatigue crack oriented in the forward direction and about the 2 o'clock position. b) The SEM micrograph shows the fatigue crack fracture surface located at the outer skin rivet hole (left). The bracket shows the region of crack initiation and the dashed line marks the fatigue crack front. c) The SEM micrograph shows the fatigue crack front region "c" in Figure 11.14.b. The dashed line marks the fatigue crack front where it intersects the rivet hole (left). The outboard surface of the outer skin is located at the top of the micrograph.
